## **CandCNC Tech Support**

### **IMPORTANT FIELD MODIFICATION of THC SENSOR CARD FOR ALL MP3000-DTHC and BLADERUNNER DRAGON-CUT UNITS.**

## IMPORTANT MODIFICATION FOR ALL THC SENSOR CARDS

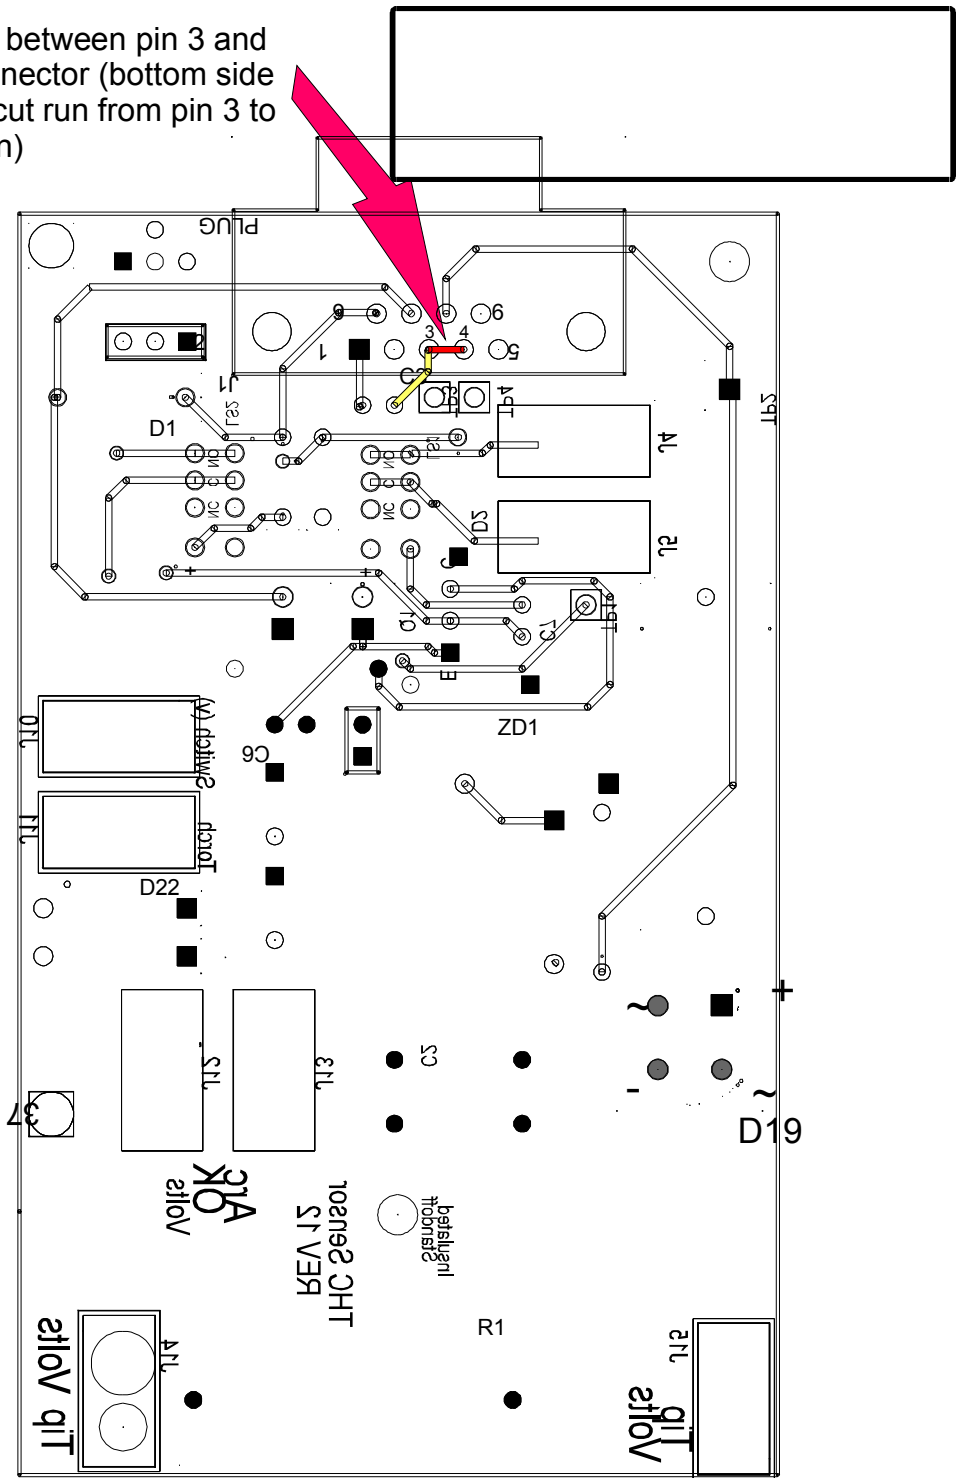
**BOTTOM VIEW  
NOT ALL RUNS  
SHOWN**

In preparation for a new digital current probe product to be introduced this summer, we made changes to the DB9 connection pinout of the DTHC module. We used what we thought was an open pin on the connector to tie in voltage for the external probe (which will connect to a new model THC Sensor Card). The existing THC SENSOR Card has that "unused" pin tied over to another pin. We missed it. The result is that on some of the MP3000-DTHC and BladeRunner Dragon-Cut models you could experience intermittent DTHC operation or possible ARC OK failures. We apologize for the mistake and by making one cut on the card the problem can be resolved. If you think your MP3000 or BladeRunner Dragon-Cut has been damaged (won't self test) or fails to operate correctly **after** the modification please contact us via phone (903-364-2740) or by e-mail (tom@candcnc.com).

Cut this (red) run between pin 3 and 4 on the Db9 connector (bottom side of card) Do **not** cut run from pin 3 to C3 pin.(yellow run)

Bottom of THC SENSOR Card (REV12) view. Turn card over and locate pins 3 and 4 on the Db9. There is a small board run (connection) between pins 3 & 4. It must be cut/removed. Cut it with a sharp object. After the cut, test for continuity (ohmmeter or continuity tester) to make sure the connection is broken. There should be NO Connection (infinite resistance). DO NOT CUT ANY OTHER RUNS. See the next page for possible re-calibration steps if needed.

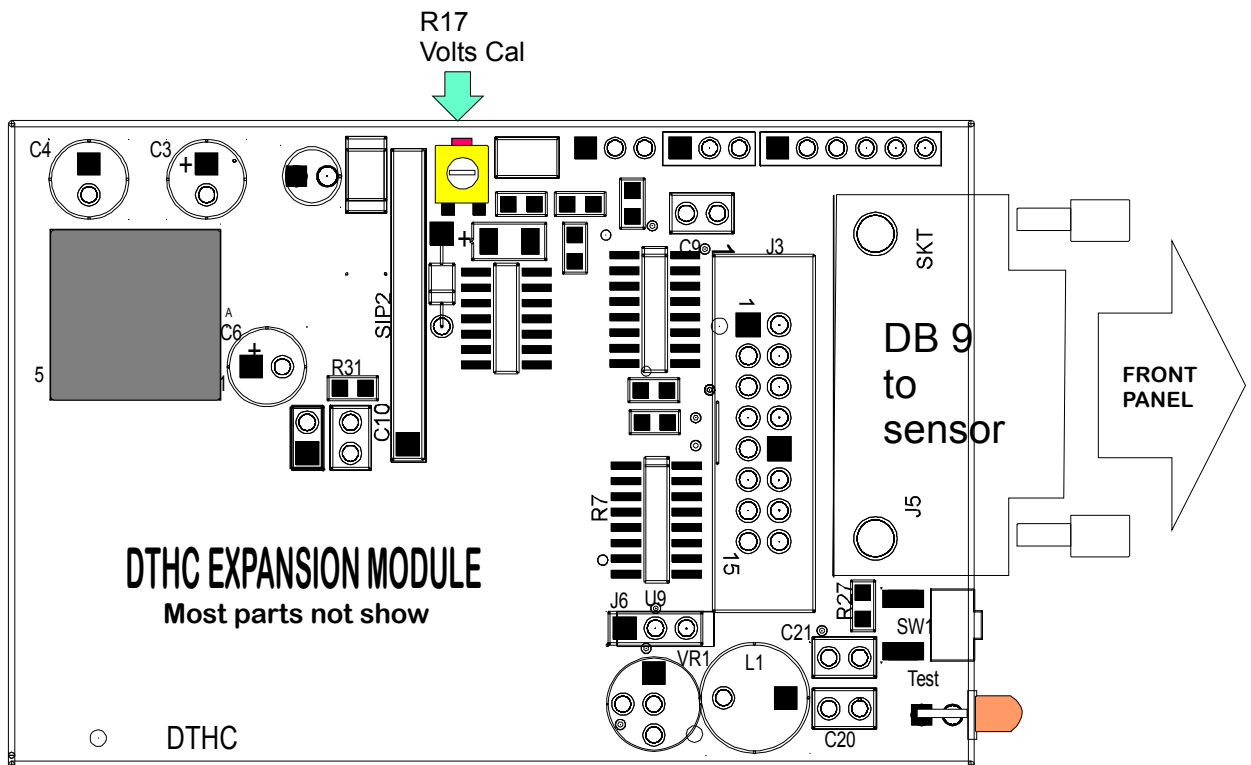
**IMPORTANT: DO NOT RE-CALIBRATE YOUR DTHC UNLESS YOU HAVE DONE THE MODIFICATION ON THE THC SENSOR CARD LISTED AND YOU OBSERVE THAT THE VOLTAGE WHEN RUNNING APPEARS TO BE ABOUT 10% LOW. SOME UNITS MAY NOT NEED TO BE RECALIBRATED. NORMAL FACTORY CALIBRATION SHOULD NOT BE CHANGED FOR ANY OTHER REASON**

DTHC Card is located inside MP3000-DTHC and Dragon Cut behind front panel, and held in place by the two jack screws through the front panel to the DB9. You should be able to access R17 adjust pot without removing the card from the front panel. The Volts calibration is done with the THC Sensor TIP VOLTS inputs connected to a source of known DC voltage. **It's more accurate to use at least 48VDC.** Use a DVM to monitor the actual DC test volts (at the TIP VOLTS Terminals). The proper profile for MACH should be loaded and the screen will display the TORCH VOLTS reading. With a small screwdriver adjust R17 until the reading in MACH matches the actual test voltage applied. It should not take a large amount of change to bring the unit into calibration.
